8 Conclusions

8.1 General Conclusions

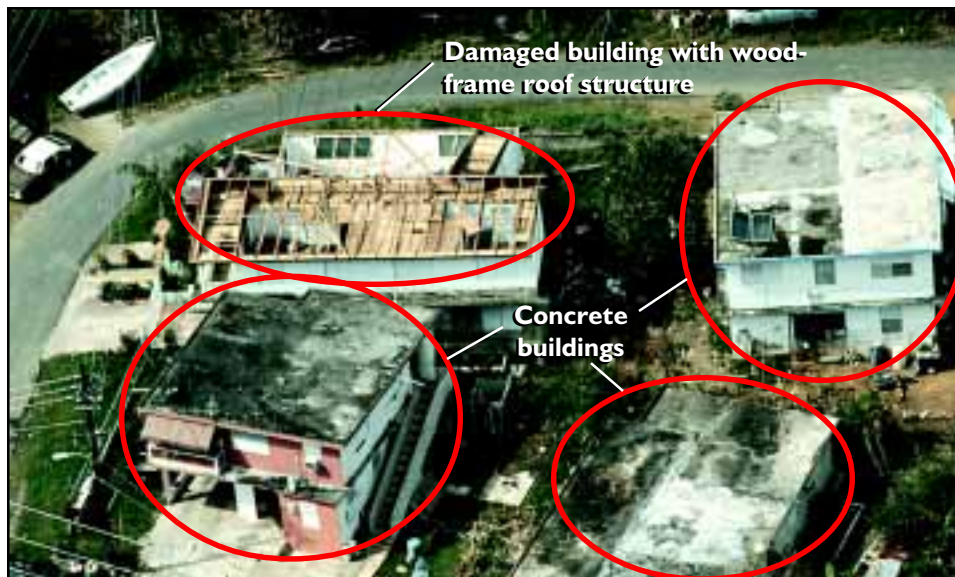
The most prevalent and successful mitigation measure the BPAT observed was the use of concrete and masonry for the construction of the exterior walls and roof. Reinforced concrete and masonry envelopes almost without exception provided excellent resistance to wind forces and windblown debris. They were also extremely reliable and durable, as illustrated in Figure 8-1.

FIGURE 8-1 The three concrete/masonry buildings in this photo appeared to be undamaged. However, the building with the wood-frame roof structure experienced significant damage.

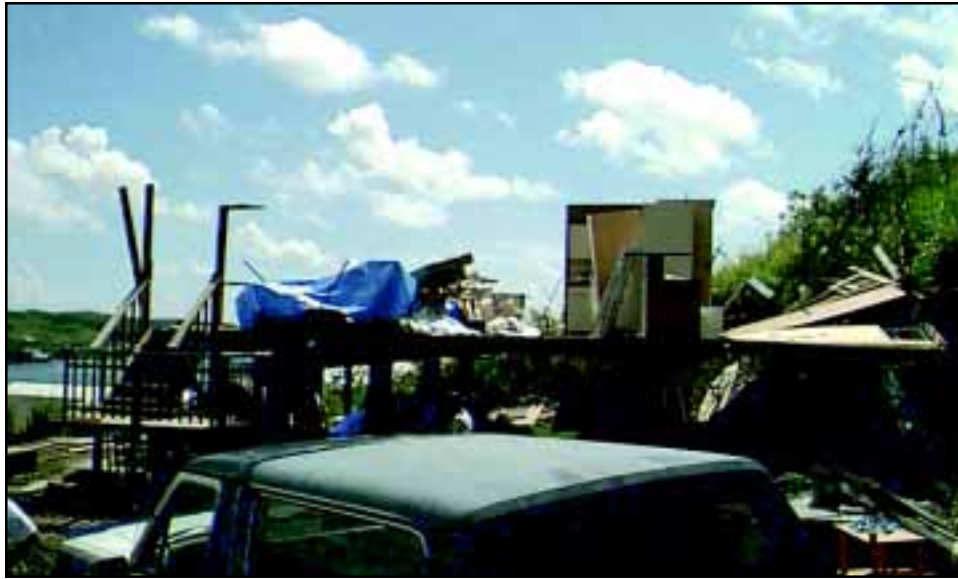
Although the BPAT observed many wood-frame building failures, as illustrated in Figure 8-2, wood-frame buildings perform well in high winds if effective mitigation measures are taken during design and construction. This is illustrated in Figure 8-3.

FIGURE 8-2 This wood-framed house was nearly totally destroyed. This is in remarkable contrast to the nearby building shown in Figure 8-3.

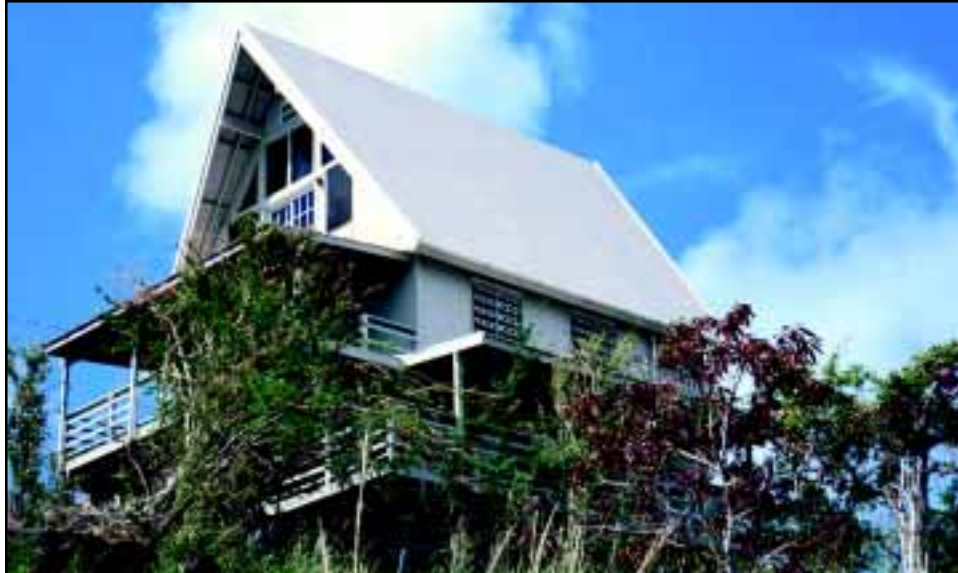
FIGURE 8-3 This wood-framed house is close to the house shown in Figure 8-2. The wind flow was essentially identical at these two sites, hence the successful performance of the one building is attributable to the attention given to design and construction. The value of mitigation is clearly illustrated in these two starkly different cases.
